INTERAGENCY STATE  
BURNED AREA EMERGENCY RESPONSE  
(BAER) REPORT-Team 10  
**SMALL FIRES**

Affecting watersheds in the Counties of  
Los Angeles, Santa Barbara,  
San Diego and Ventura  
CALIFORNIA

November 11, 2007

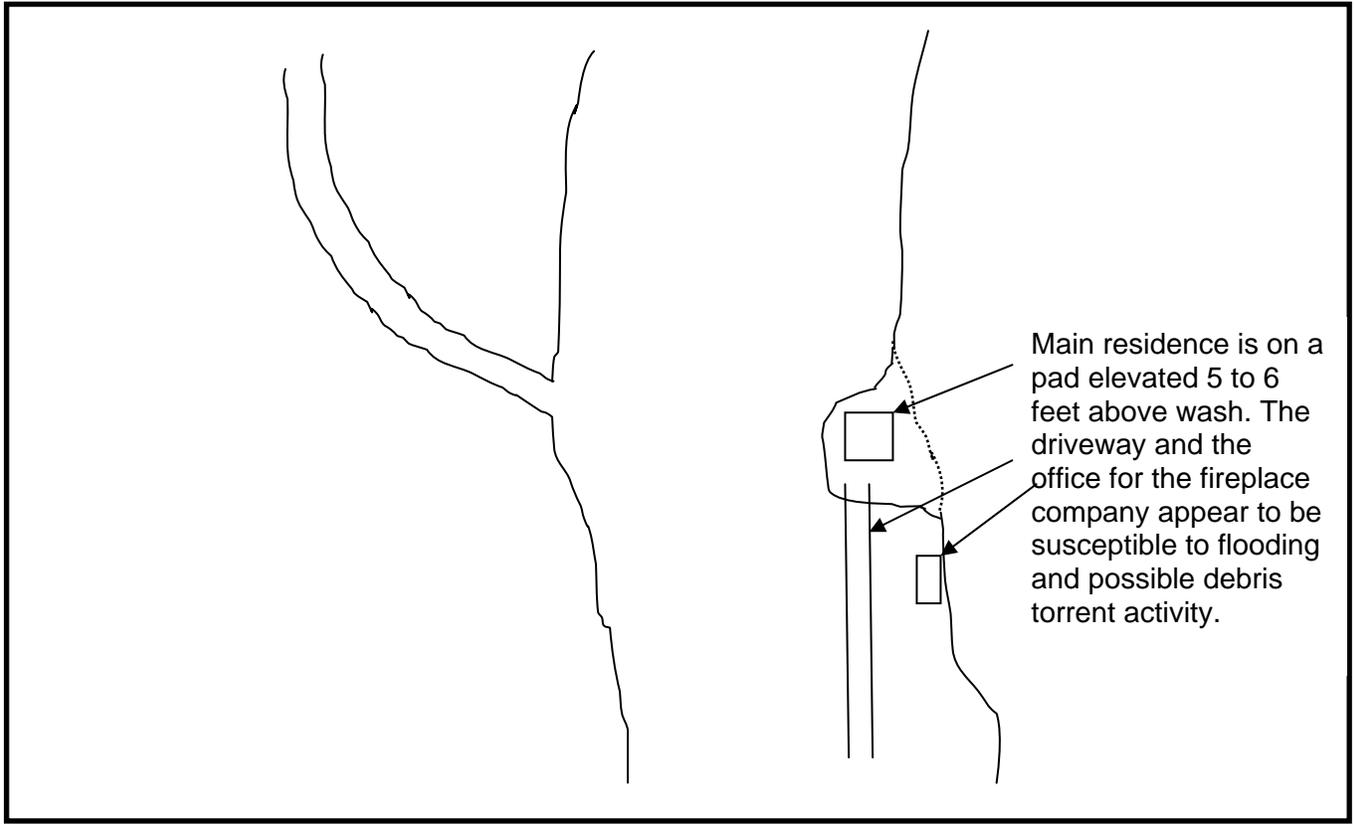
**Sketch**

The main wash along Meyers Canyon is roughly 150 to 200 feet wide. The main residence does not appear to be at risk, but it appears that additional protection could be provided to the access drive and the older residential structure by grading along the wash.

14. Treatment options  yes  no
- surficial erosion control
  - channel clearance/improvements
  - structures (describe conditions and goals)
- other: **Staff forYe Olde Brit Fireplaces & BBQ Islands should not occupy the office building during storms.**

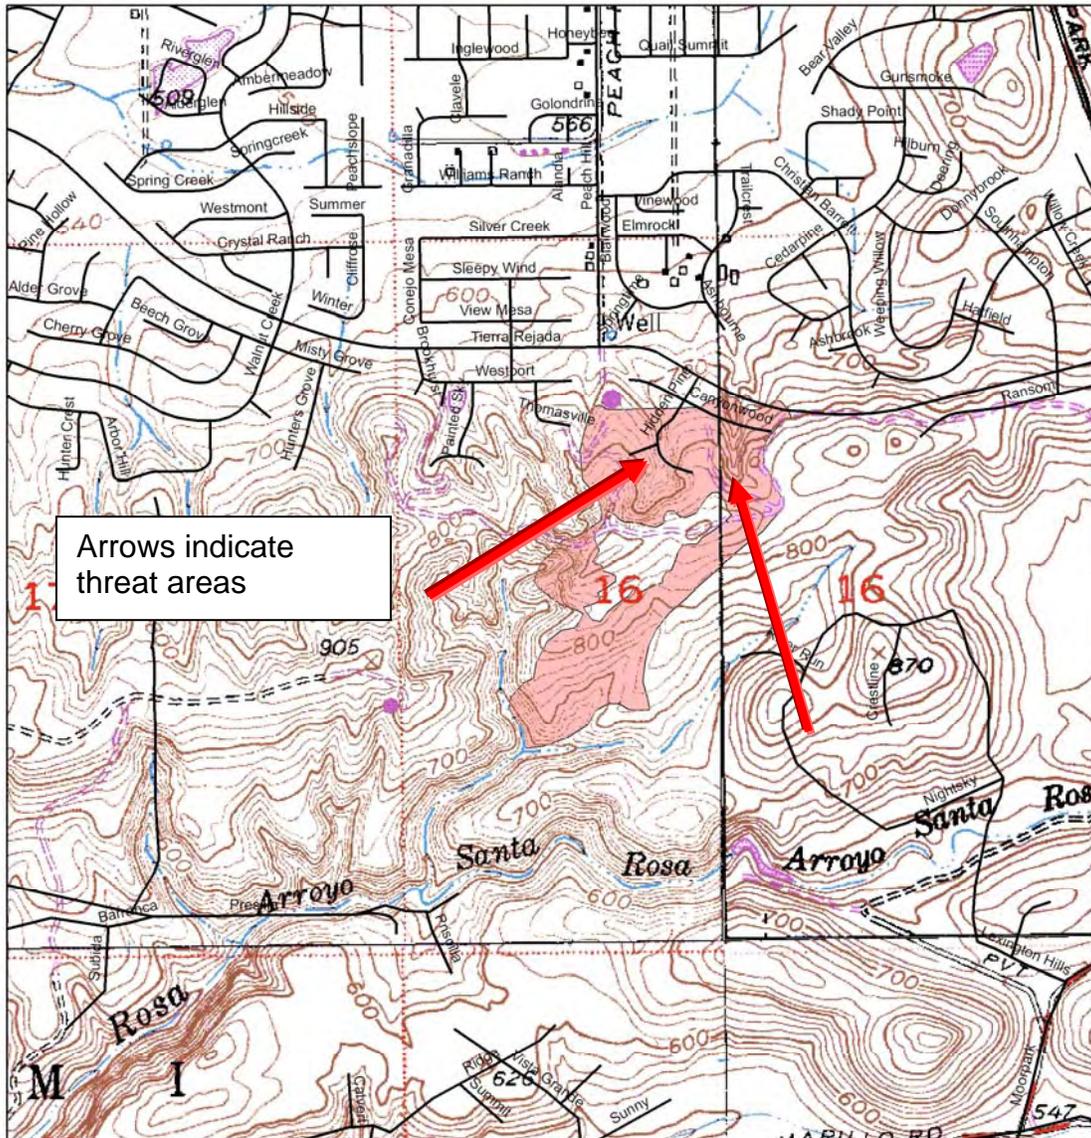
Fire burned between residential developments on a major ridgetop and within two small catchments that drain into a subdivision (figure 1). The fire burned with moderate severity within the two small basins, leaving the sandy loam soil with an average residual ground cover of 20%. Vegetation consists of brush 4-8 feet tall with small diameter limbs (2" diameter and less). The basin to the west is approximately 10 acres and the basin to the east is approximately 8 (figures 2-3). Each of these basins drain to the north and into 36 inch culverts with concrete abutments (figures 5-6). Slopes within the basins are generally steep (>70%) and the ridge tops are gentle (10-20%). There is concern that a heavy rain event could produce excessive sediment possibly clogging the drain culverts. If this situation arose, water could flow into the subdivision possibly damaging 4 structures. In addition to these 4 structures the Geology Report completed on November 11, 2007 identified 4 additional houses at risk. (See attached Geology Report, Appendix # )

Arrows indicate threat areas

- Recommended removal of debris from canyon to protect culvert and adjacent homes

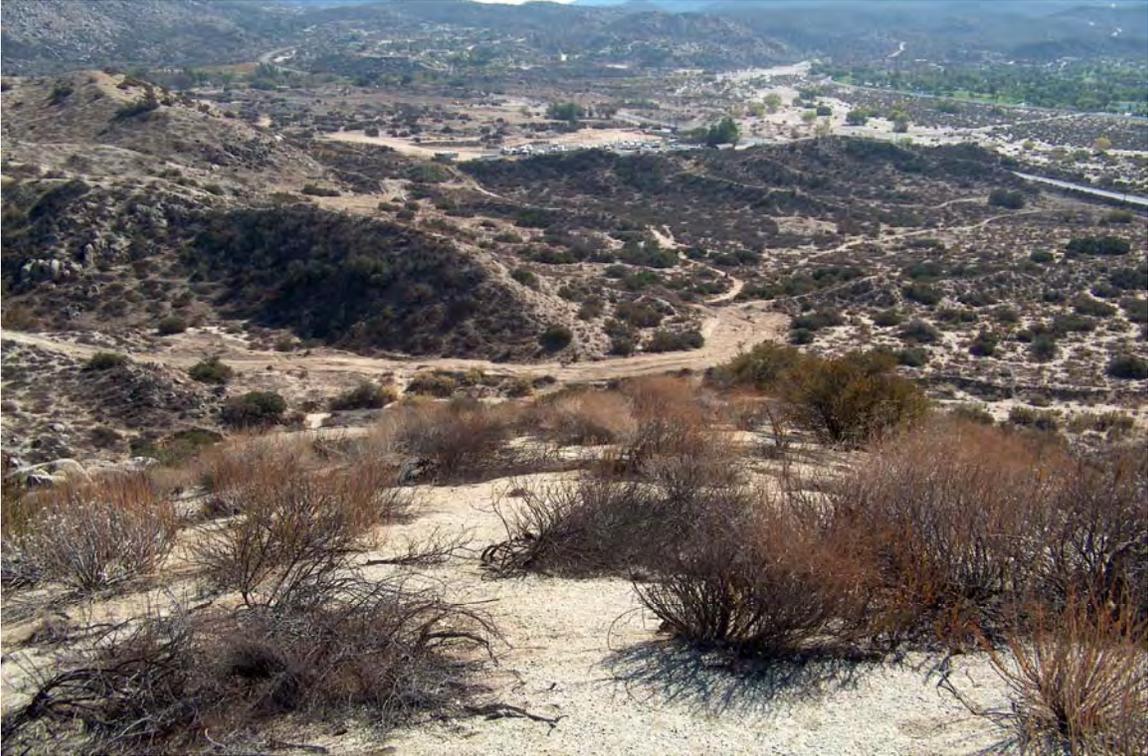
Tractor Fire Line in Steam above Residence at Risk

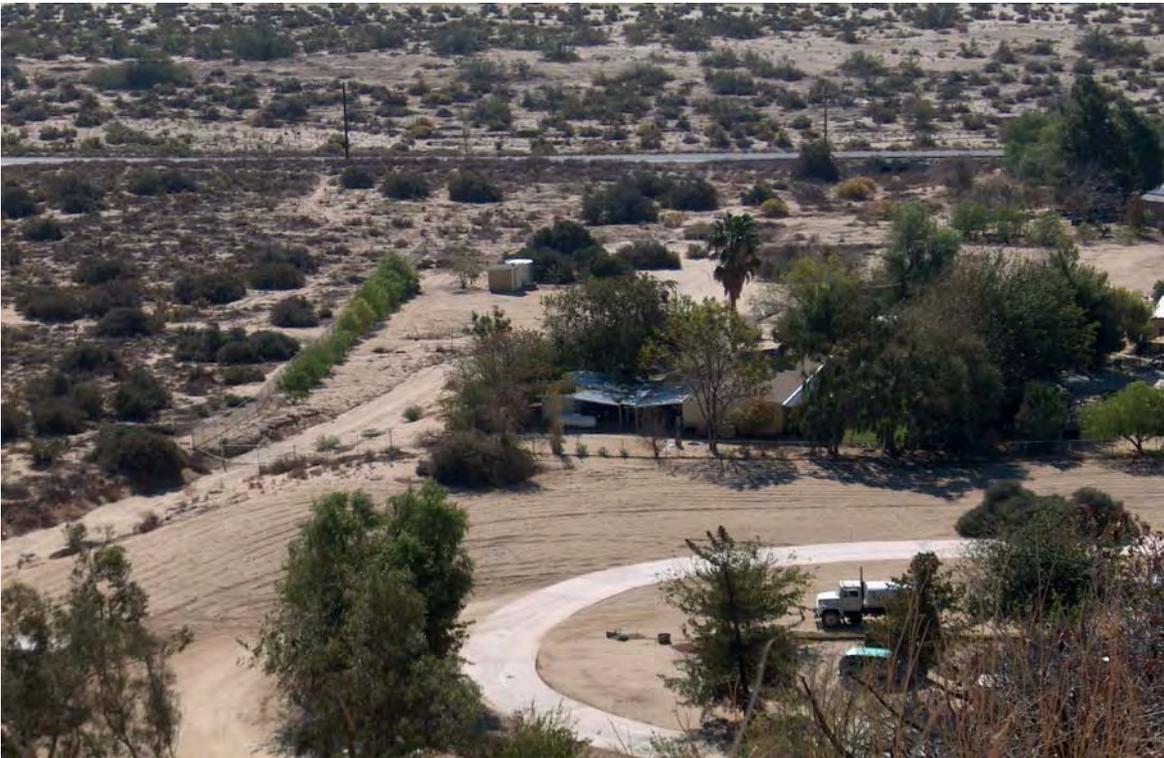
Residence at Risk

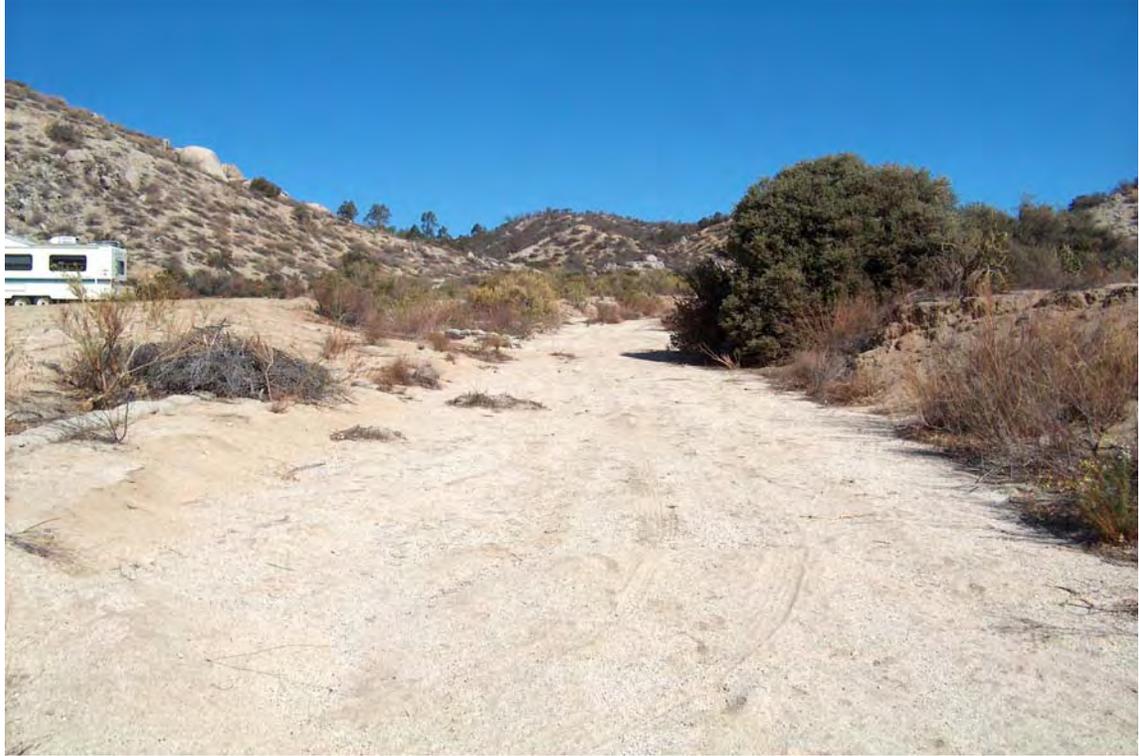
Stream Leading to Residence

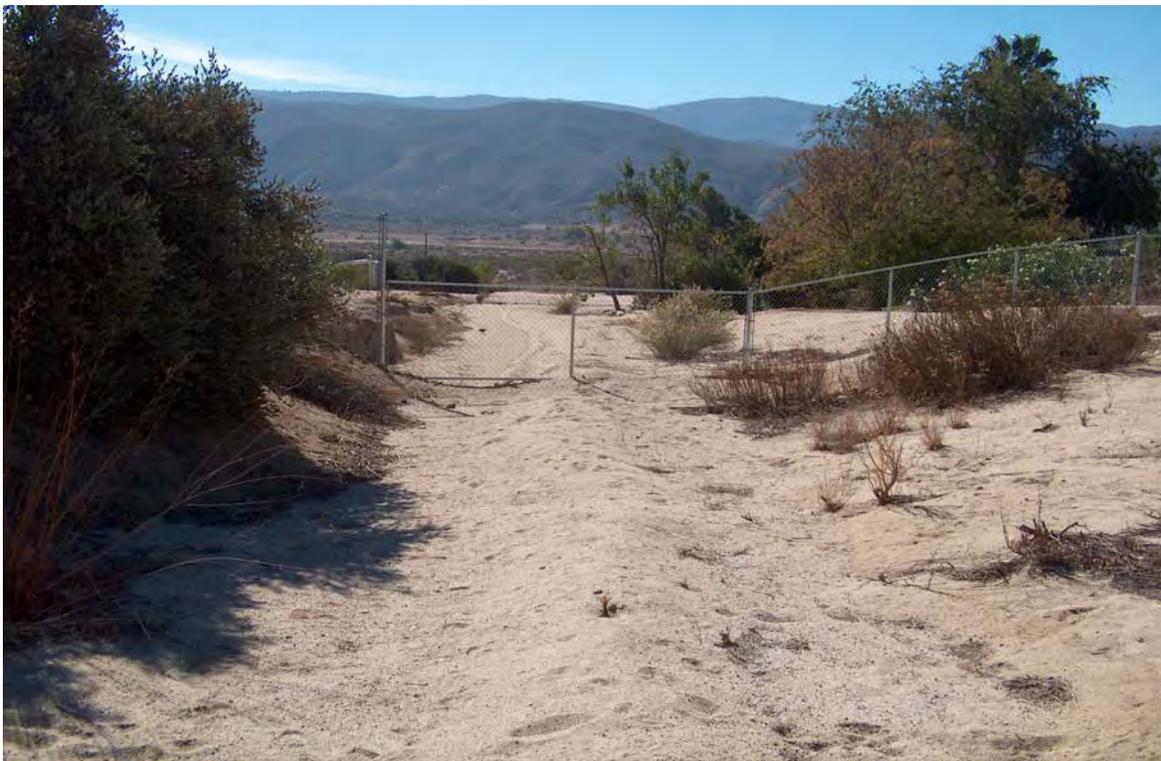
Stream Hitting Fence Line at Residence
