INTERAGENCY STATE
BURNED AREA EMERGENCY RESPONSE
(BAER) REPORT

THE WITCH FIRE

Affecting watersheds in the
County of San Diego
CALIFORNIA

November 17, 2007

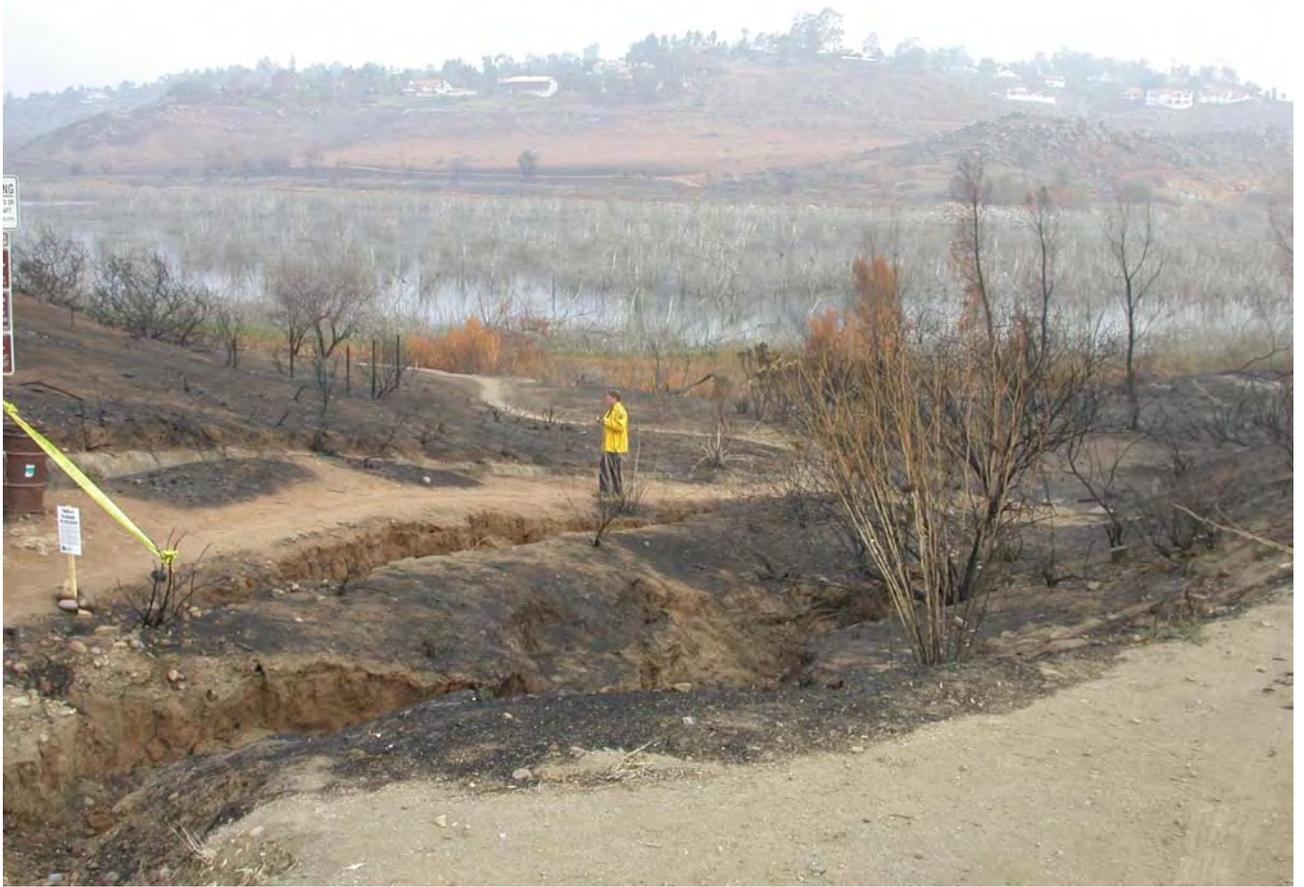
RB 102A

Site #	At-Risk Feature	Street Address	GPS location		Hazard	likeli- hood	Risk to lives		Risk to property	
			Lat (North)	Long(West)			Fire	pre-exist	Fire	pre-exist
RB102	Hillside drainage		N33.054449	W117.07526	Debris Flow	M-H	L	L	H	L-M
RB103	Hillside drainage		N33.05436	W117.07511	Debris Flow	L	L	L	L	L-M
RB104	Road/Houses		N33.04213	W117.09159	Debris Flow	M	L	L	M	M
RB105	Houses		N33.03865	W117.09196	Debris Flow	M	M	L	M	L
RB106	Houses		N33.03809	W117.09105	Debris Flow	M	L	L	M	L
RB107	Hillside drainage		N33.03275	W117.09390	Debris Flow	M	L	L	M	L
RB108	Houses/Road		N33.02805	W117.10390	Debris Flow	M	L	L	M	L
RB109	Hillside drainage		N33.04104	W117.00416	Debris Flow	H	M	L	H	L
RB110	Hillside drainage		N33.00529	W117.02352	Debris Flow	M	L	L	M	L
RB111	Hillside drainage		N32.98909	W117.02326	Debris Flow	M	L	L	L-M	L
RB202	Water Resources		N33.00740	W117.02337	Debris Flow	L	L	L	L	L
RB203	Hillside drainage		N33.01922	W117.02863	Debris Flow	H	M	L	H	L

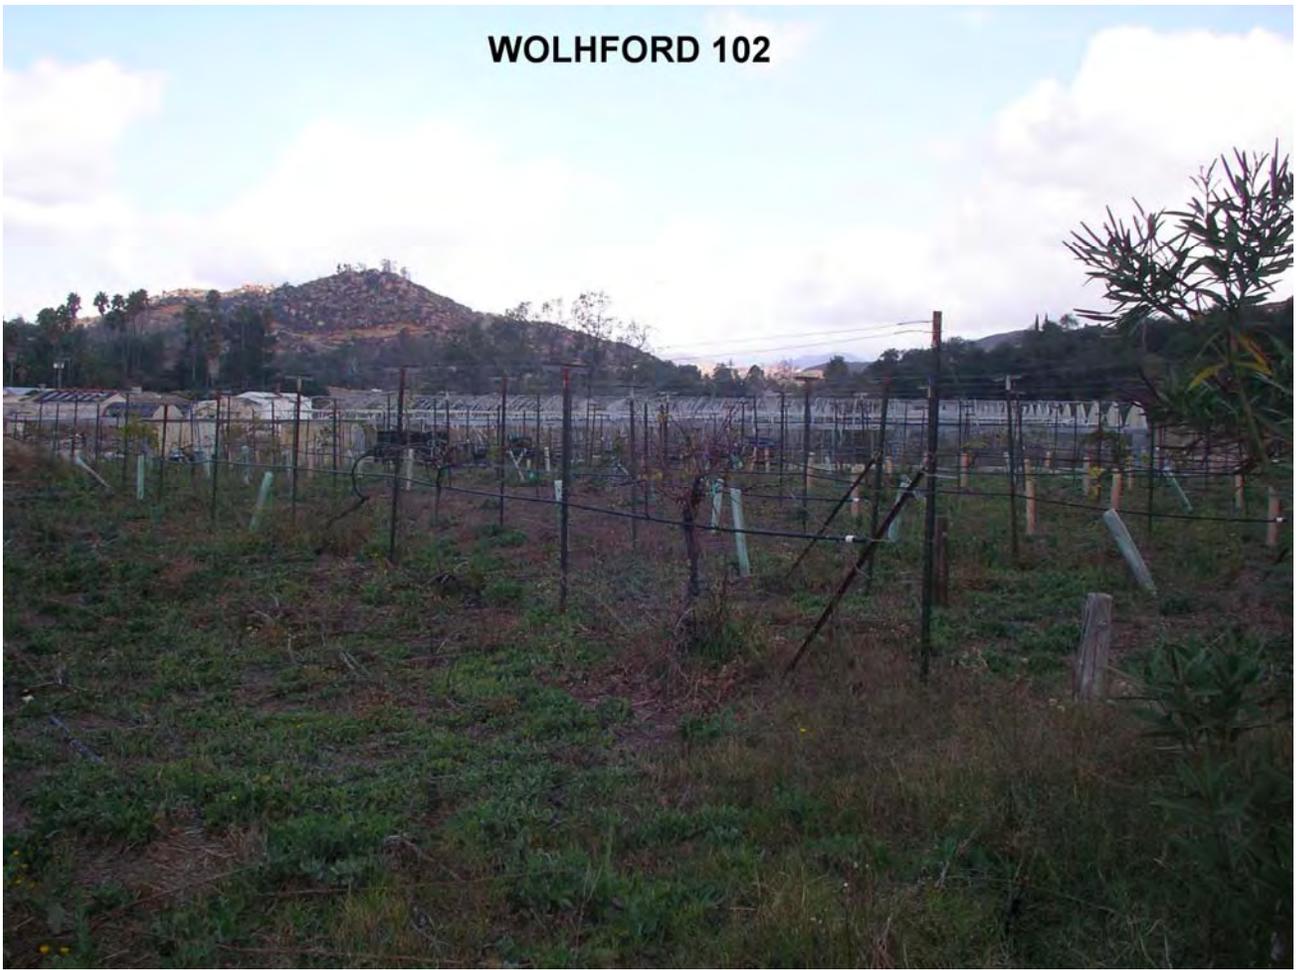
WOLHFORD 101

Site number	At-risk Feature	Street address	GPS location		Hazard	Likelihood	Risk to lives		Risk to property	
			Latitude N	Longitude W			fire	pre-exist	fire	pre-exist
Wlfrd 101	3 houses with business		33.14579	116.97480	Flood	Low	Low	Low	Low	Low
comments	Roads in this area (Old Yucca, Old Manzanita) are narrow, incised and mostly unpaved, may have erosion and flooding problems. Numerous draws come in from above, road has poorly maintained inside ditches, culverts and outside berms. Culverts need cleaning, berm needs to be knocked down.									
Wlfrd 102	Nursery, buildings, businesses.		33.15601	116.97456	Flood	Mod	Low	Low	Mod	Low
comments	5 houses in the area generally above draws and swales. The swales coalesce in vicinity of the nursery grounds. See photo 180 for pictures of swales and draws									
Wlfrd 103	Out building /storage		33.15130	116.98717	Flood	Mod	Low	Low	Mod	Low
comments	Near complex of many buildings and grounds for "Self Realization Center" Although houses located out of draws, the road is in the bottom of the drainage with potential for flooding in heavy rain event. Photos 178, 179
