Burn Area Recovery Task Force (BARTF) Report Orange County Santiago Fire

Executive Summary

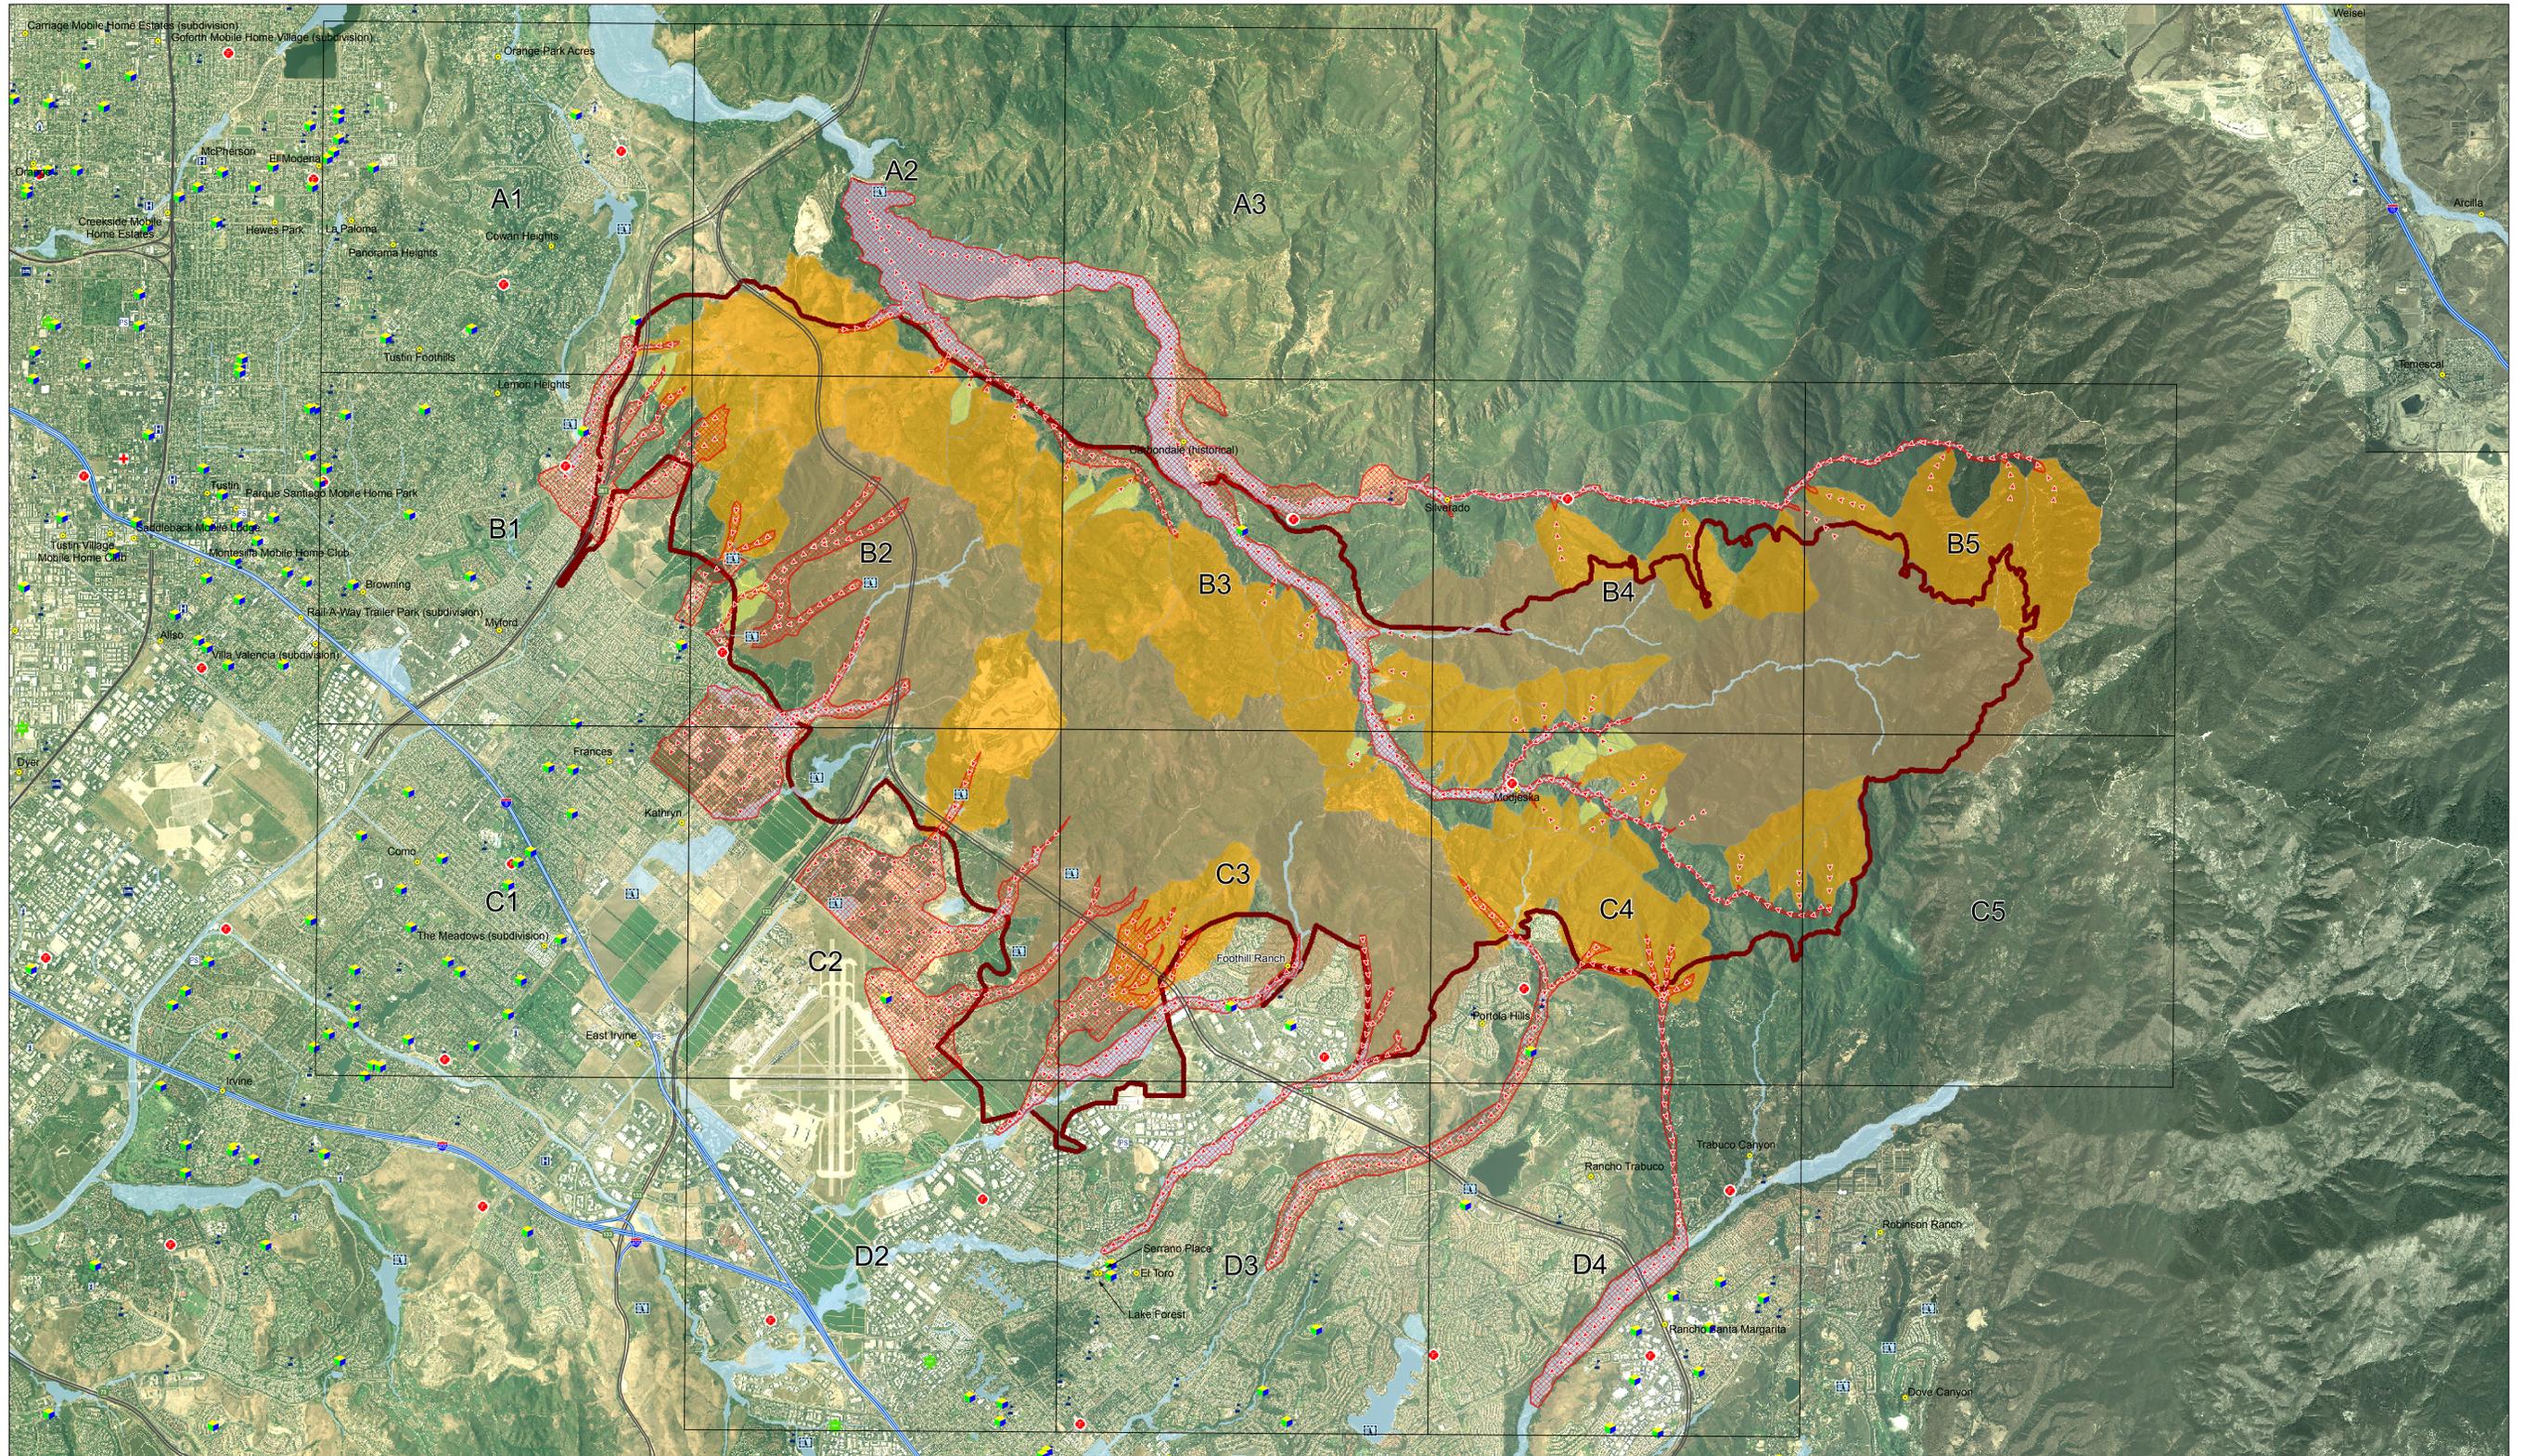
MAPS FOR ADVISORY PURPOSES ONLY. NOT FOR INSURANCE RATING PURPOSES. For insurance rating purposes, please refer to the Flood Insurance Rate Map currently in effect. Debris flow information is PRELIMINARY. Debris flow volumes calculated in response to a 10 year recurrence based on 3 hour duration storm producing 1.75 inches of rainfall. Volumes based on a model currently being tested. Debris flow behavior is highly unpredictable and this map shows the best available information at the time of printing. Populations estimated using 2000 Census data and are calculated for those areas only within the grid index.
