INTERAGENCY STATE  
BURNED AREA EMERGENCY RESPONSE  
(BAER) REPORT-Team 10  
**SMALL FIRES**

Affecting watersheds in the Counties of  
Los Angeles, Santa Barbara,  
San Diego and Ventura  
CALIFORNIA

November 11, 2007

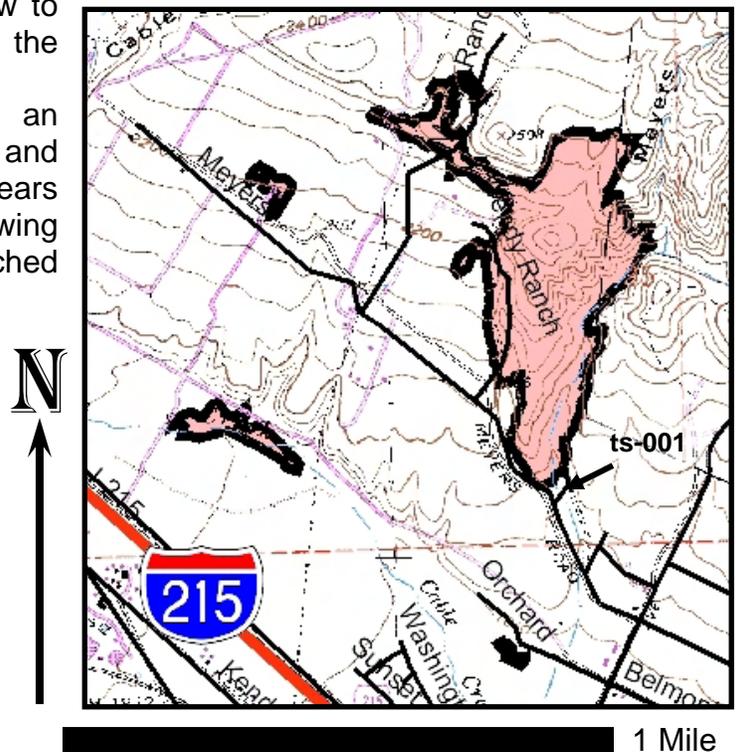
The Martin Ranch fire exhibited low to moderate soil burn intensity on the steeply-sloping canyon walls of Meyers Canyon. One structure, an office building for a fireplace and bar-b-que island company, appears to have an increased risk following toe fire. Please refer to the attached CGS Burn Site Evaluation.

1. Structure(s) infrastructural element at risk: <input checked="" type="checkbox"/> house <input type="checkbox"/> business <input type="checkbox"/> major road <input type="checkbox"/> local road <input type="checkbox"/> trailer <input type="checkbox"/> tank <input type="checkbox"/> culvert <input checked="" type="checkbox"/> other <u>office</u>

2. Watershed / hillslope feature characteristics: a. <input type="checkbox"/> small watershed <input checked="" type="checkbox"/> large watershed <input type="checkbox"/> colluvial hollow <input type="checkbox"/> steep slope <input type="checkbox"/> cut slope <input type="checkbox"/> other _____ b. size _____ ac. c. slope (average and range) <u>30% to 90%</u> d. channel presence <u>yes</u> , channel grade <u>2%</u> e. riparian vegetation condition: <u>Intact vegetation, mostly willow</u>		
<u>Observations</u>

1. Percent of watershed burned <u>30%</u>		
2. Geology: Formation or unit name (if available) <u>Old alluvial fan deposits with alluvial wash gravels</u> lithology: <u>Poorly sorted, clast supported boulder, gravel fanglomerate fabric massive</u> penetrative structures: <input type="checkbox"/> yes <input checked="" type="checkbox"/> no, type _____ orientations _____ regolith/soil: texture – <u>sandy gravel</u> thickness: <u>soil consistent with underlying material</u> other _____

5. Pre-fire vegetation  grass  chaparral  trees  hardwood grass woodland  other \_\_\_\_\_
6. Soil burn severity (Parsons, 2003): high 5% moderate 30% low 65% of the burn area
7. Post fire ground cover: vegetation/litter/leaf fall 30% surface rock 25% total cover 55%
8. Hydrophobic soil development:  high  moderate  slight  
 continuity of hydrophobic layer:  high  moderate  low  
 thickness of wettable layer above hydrophobic layer \_\_\_\_\_  
 post-fire bioturbation  None  Moderate (5-20%)  High (>20)  
 type  gopher  ant  hoof print  Other \_\_\_\_\_
9. Potential post-fire hazards:  
 flood  sediment concentrated flood  debris torrent  future landslide potential from slope  
 other \_\_\_\_\_

14. Treatment options  yes  no
- surficial erosion control
  - channel clearance/improvements
  - structures (describe conditions and goals)
- other: **Staff forYe Olde Brit Fireplaces & BBQ Islands should not occupy the office building during storms.**

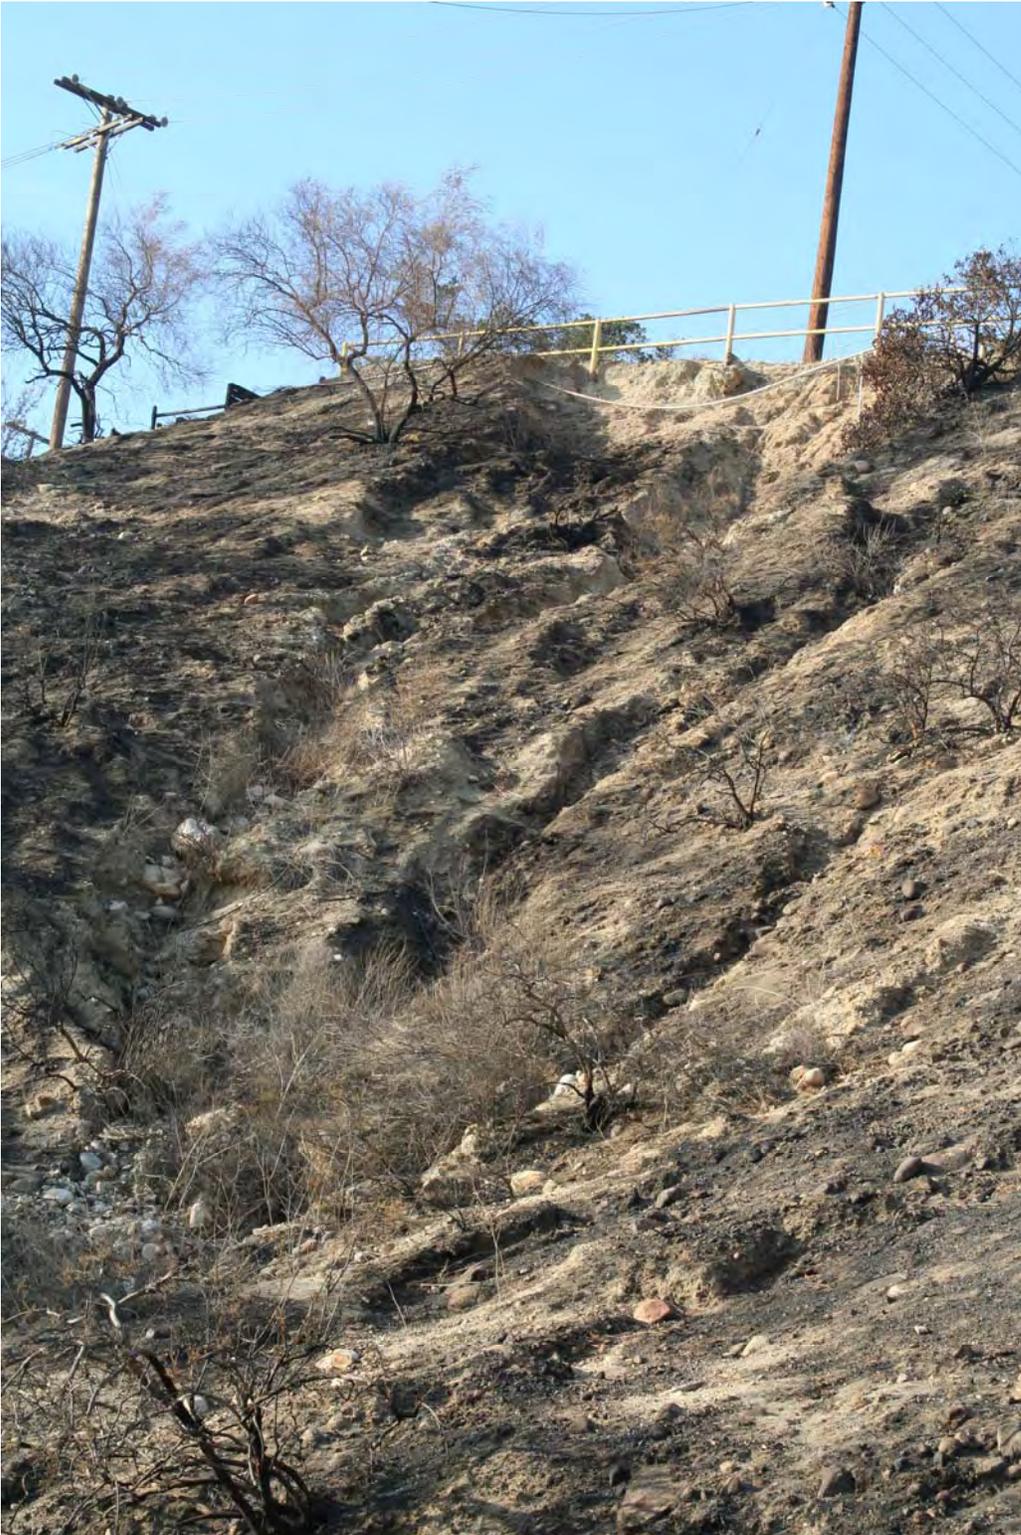
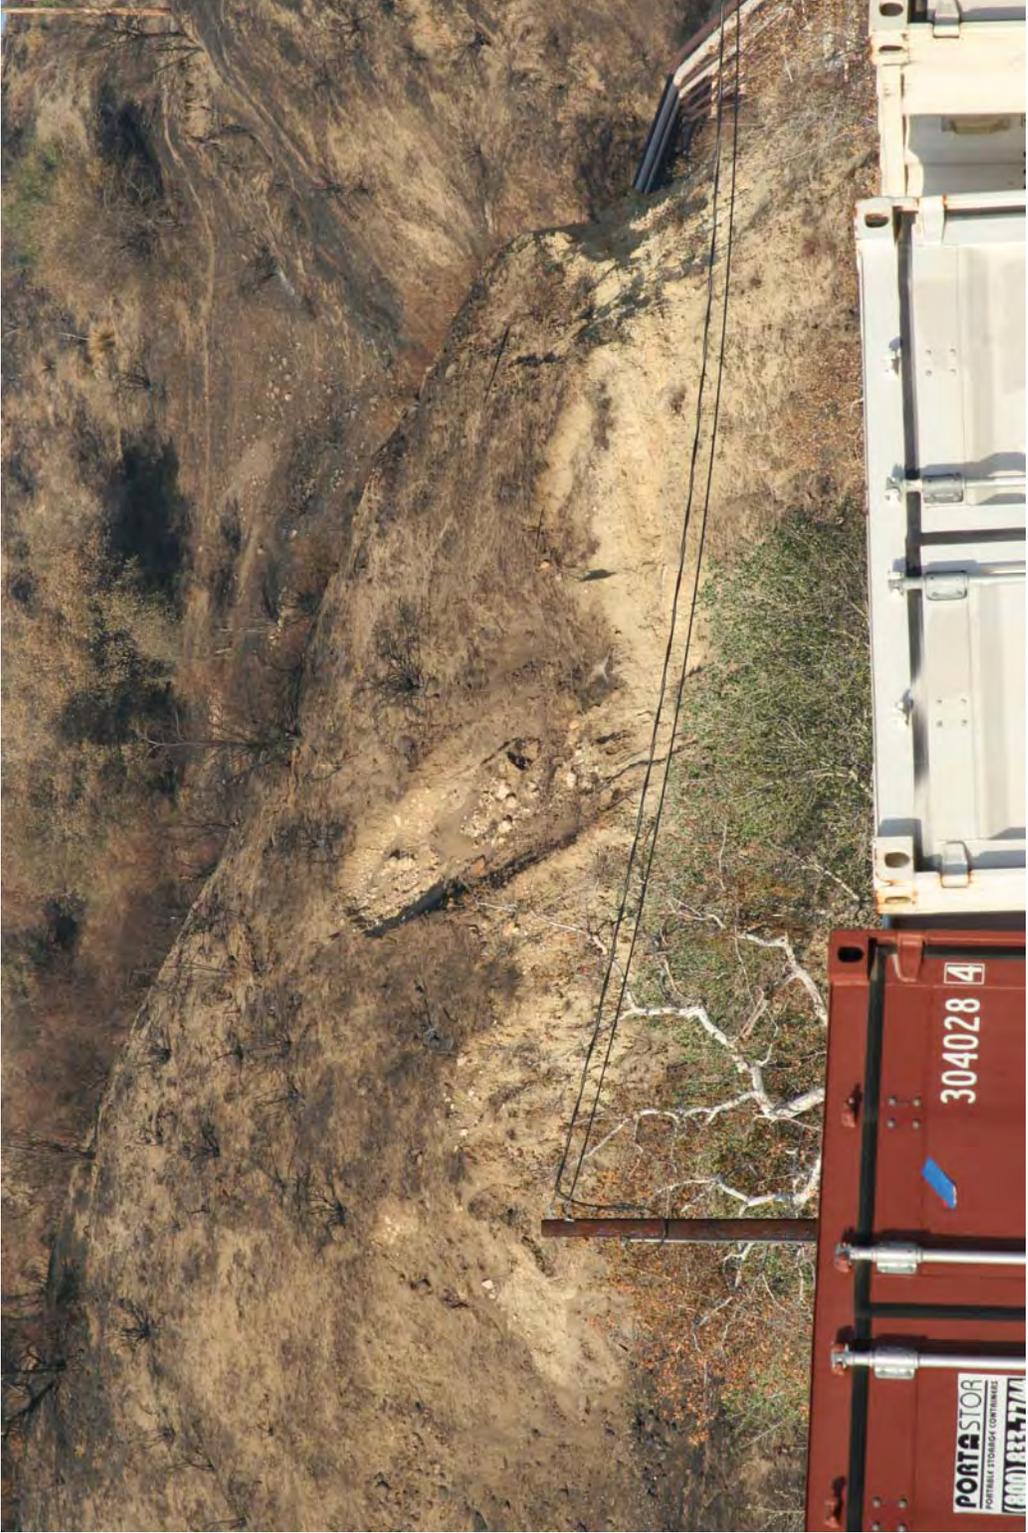
## Appendix #2 Photos

- For the October Incident, evaluated on November 6<sup>th</sup>, they found that improvements in the form of oil well piping and shipping containers and resources such as intermittent streams and certain plant species may be at risk from existing shallow seated slides on a steep hillslope above these items of concern. They proposed no mitigations, but did propose further evaluations by a Fisheries Expert, Geologist, and a botanist. The Geology Report for this incident reiterated the need for further geologic review, with this to be completed by the Oil Company and LADWP who jointly either occupy or own this land where the incident occurred. (See individuals Team Report, Attachment #4)

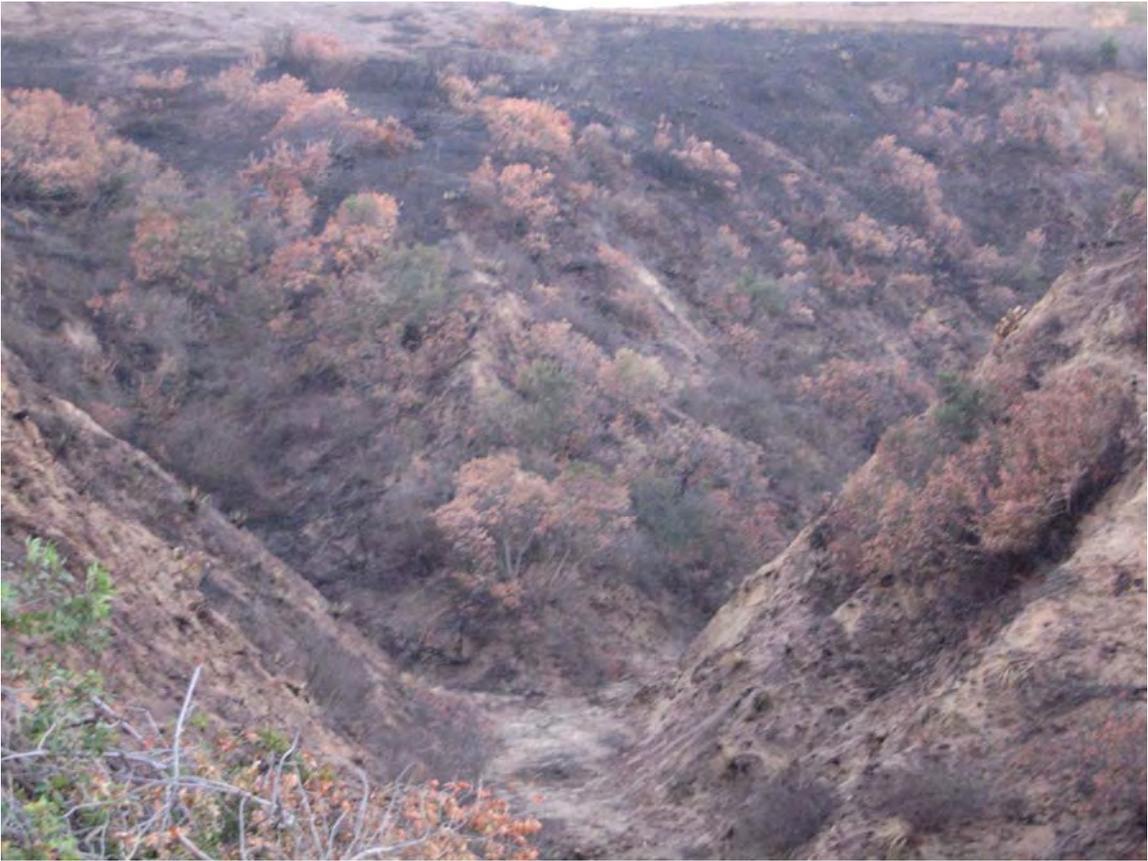
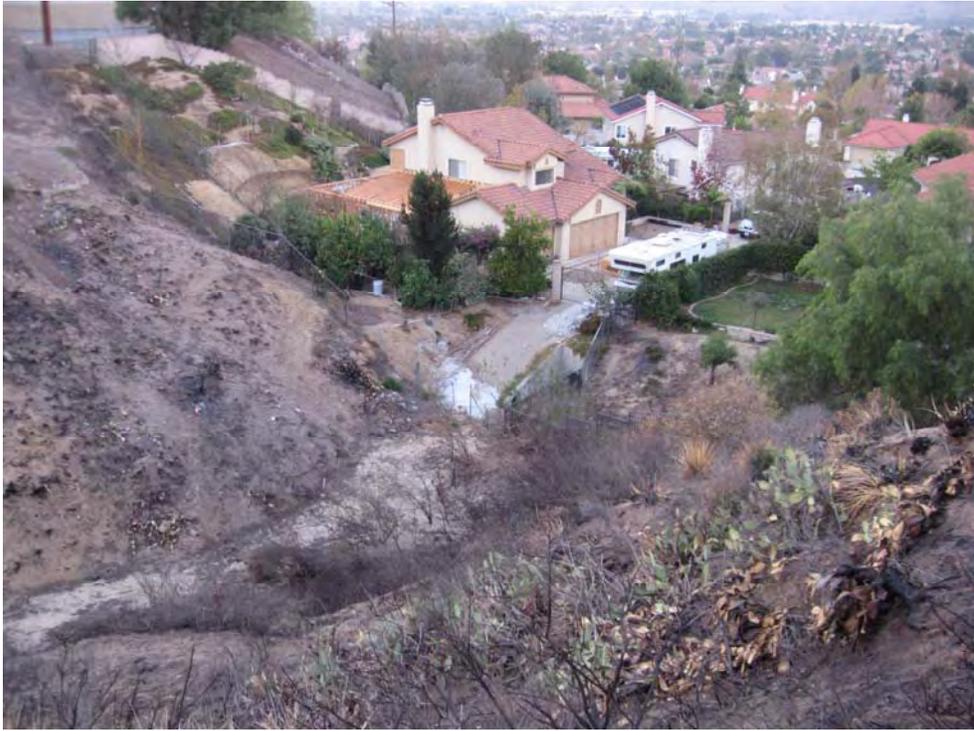
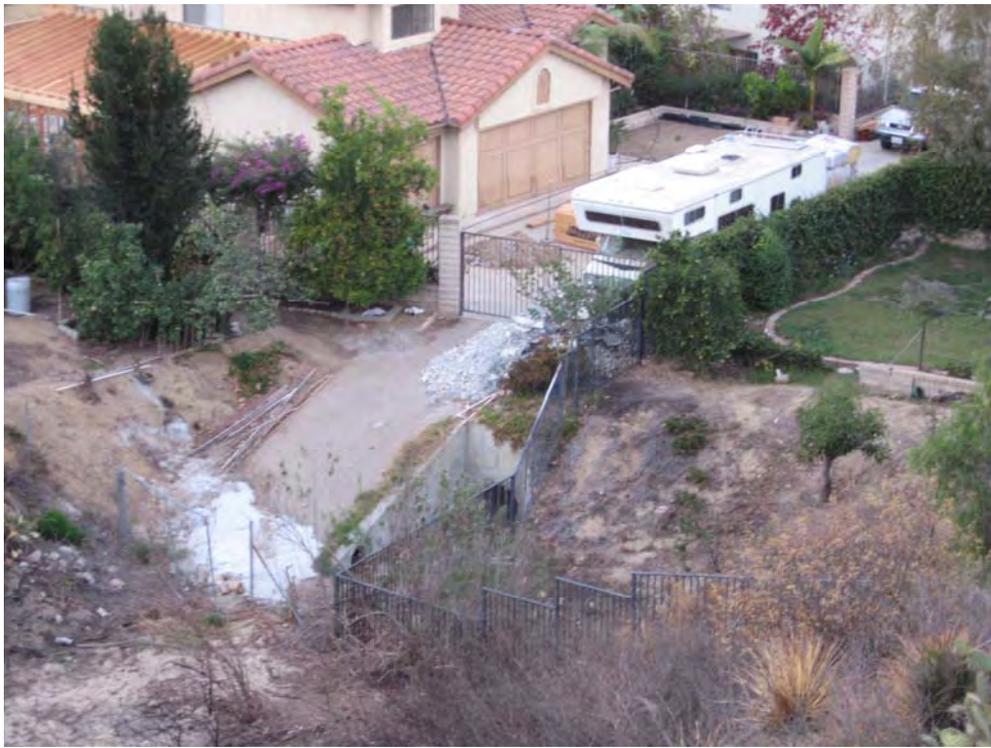
### Appendix #3 Photos

- For the Nightsky Incident, evaluated on November 6<sup>th</sup>, they found two catch basins below steep burned hillsides where there was a potential for these basins to clog and damage at least 4 homes near these basins. They recommended removal of debris from specific canyons to protect culverts from plugging
